2001 Lemhi River Watershed TMDL Implementation Report and 2002 TMDL Implementation Plan

**Salmon Field Office
Bureau of Land Management**

January 2002

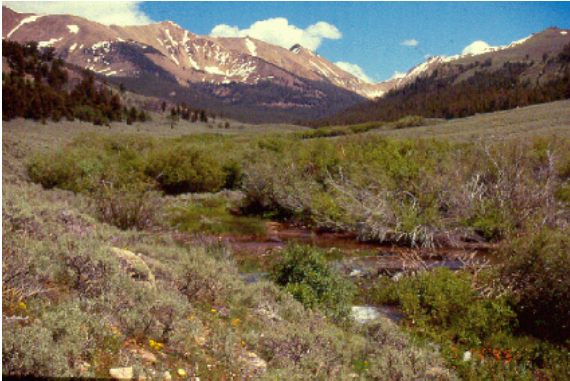
Figure 3. Eighteenmile Creek looking upstream near the Wilderness Study Area/private boundary. July 14, 1999.

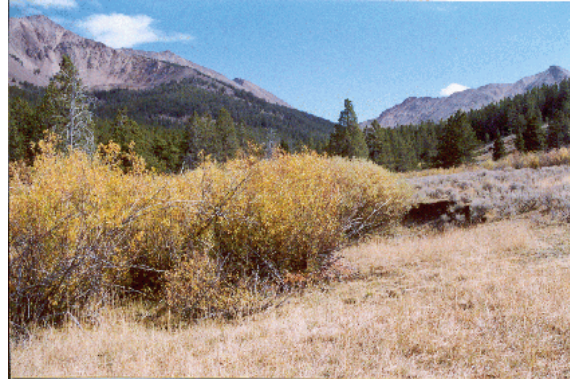
Figure 4. Eighteenmile Creek key area in the WSA. October 3, 2001.

In 2000, the BLM surveyed bank stability in the Eighteenmile Wilderness Study Area (WSA) for comparison to near natural conditions. Four reaches totaling 0.4 miles were inventoried. Bank stability ratings ranged from a low of 68% stable to a high of 88% stable with an overall rating of 85% stable. The evaluated reaches included several previously occupied beaver complexes which have lost all their dams. This loss of structure has resulted in a relatively unstable system at risk for further reductions in stability, but still above the 80% “natural” levels proposed in the TMDL.

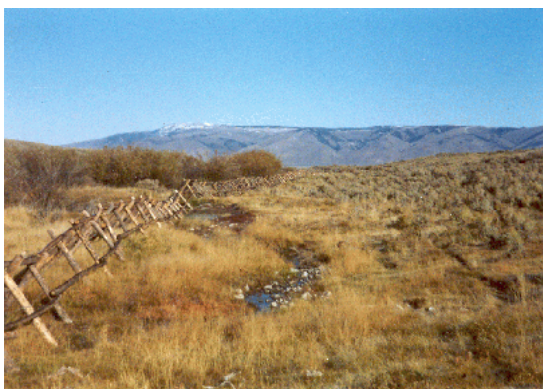
Figure 11. New section of fence for the Eighteenmile Creek exclosure. October 19, 2001.

In 2001, two of three exclosures along Eighteenmile creek were again maintained. In addition, a section of fence around the Eighteenmile exclosure located at the corners of sections 8, 9, 16, and 17 was replaced and extended to include part of the Pasture A watergap (Figure 11). The TMDL identified water crossing of pioneered two-tracks in the watershed as a significant contributor of sediment into Eighteenmile Creek. Using the information gathered in the 2000 road inventory, road improvement projects were completed in order to improve the condition of major roads and reduce the amount of traffic on pioneered two-tracks. Road maintenance completed during 2001 include the addition of two culverts and some gravel surfacing on the Clear Creek Road (Figure 12), the replacement of four cattleguards on the Eighteenmile Creek Road, and surfacing of two miles on McFarland Boulevard over areas of bentonite clay (Figure 13).

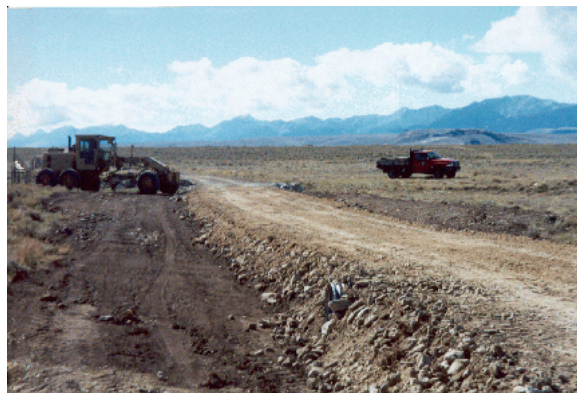
Figure 12. New culvert on the Eighteenmile Creek Road. September 2001.

A number of projects to reduce the potential for sediment production were completed during 2000 and 2001. In 2000, 12 miles of road were bladed (Tenmile Creek Road, McFarland Boulevard, Divide Creek) including reconstructing the road prism, improving drainage, and cleaning ditches. This will allow for proper water flow and reduced sediment delivery to Eighteenmile Creek. Reconstruction on the Eighteenmile Creek Road was initiated for the same reasons. Two livestock grazing exclosures on Eighteenmile Creek were maintained to continue riparian area improvement, and a culvert on Clear Creek was installed to prevent further erosion of the road surface.

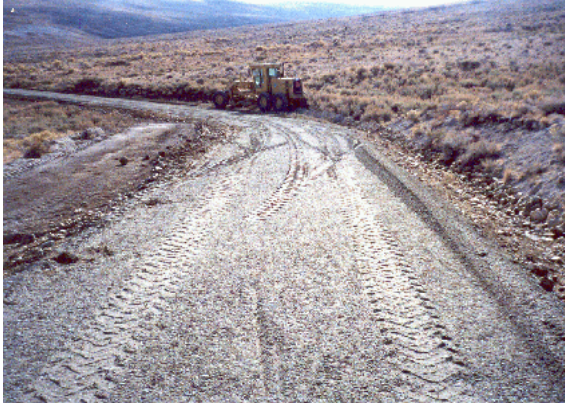
Figure 13. Gravel surfacing over areas of bentonite clays on McFarland Boulevard. November 2001.

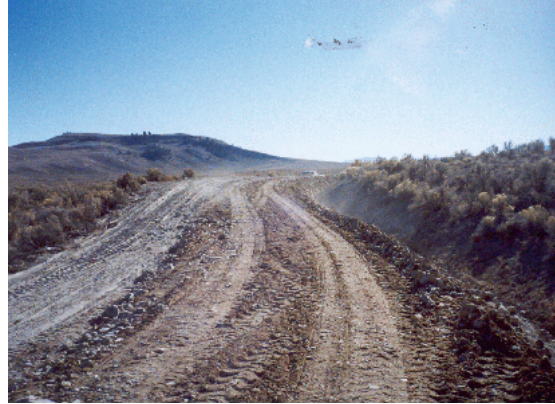
Figure 14. Improving drainage on McFarland Boulevard. November 2001.

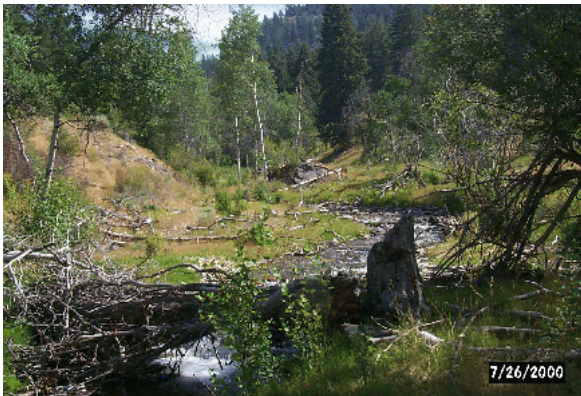
Figure 15. Geertson Creek looking upstream near the BLM/private boundary. July 26, 2000.

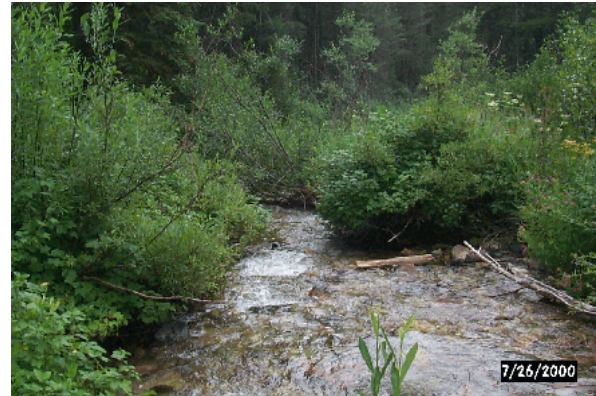
Figure 16. Geertson Creek looking downstream part way up the canyon on BLM. July 26, 2000.

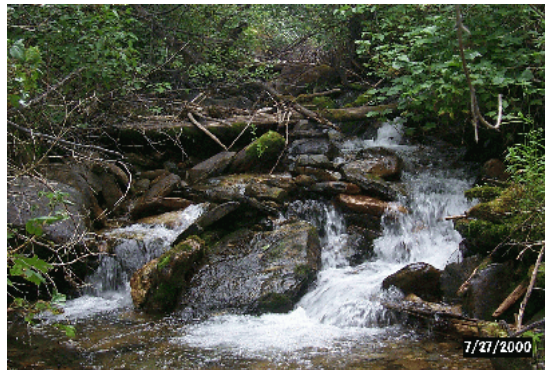
Figure 21. East Fork Kirtley Creek. July 27, 2000.

In 2001, the Upper Kirtley/Freeman Creek Road was bladed to improve drainage, reduce erosion, and address the potential for sediment production identified in the TMDL. In addition to road maintenance, an electric fence was put in place across private and BLM land at the lower end of Boomer Canyon. The purpose of this fence is to keep cattle on the lower part of private land until later in the season, allowing herbaceous vegetation to reach seed ripe and further stabilize upland conditions.

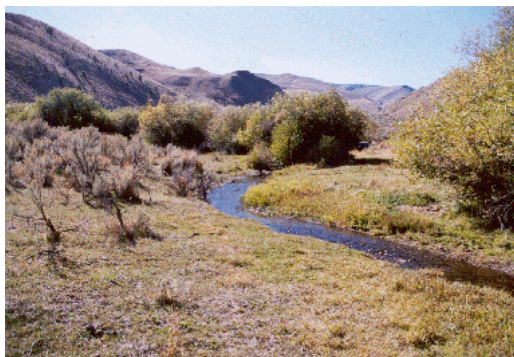
IDEQ data shows subsurface fine sediments at 44.5% which are above desired levels of <20% on McDevitt Creek. Multiple age classes of fish were not documented by IDEQ. This stream has the most lineal distance on BLM identified as requiring improvement, approximately 6.5 miles.

Figure 22. Key area on the McDevitt Creek Middle Reach. October 3, 2001.

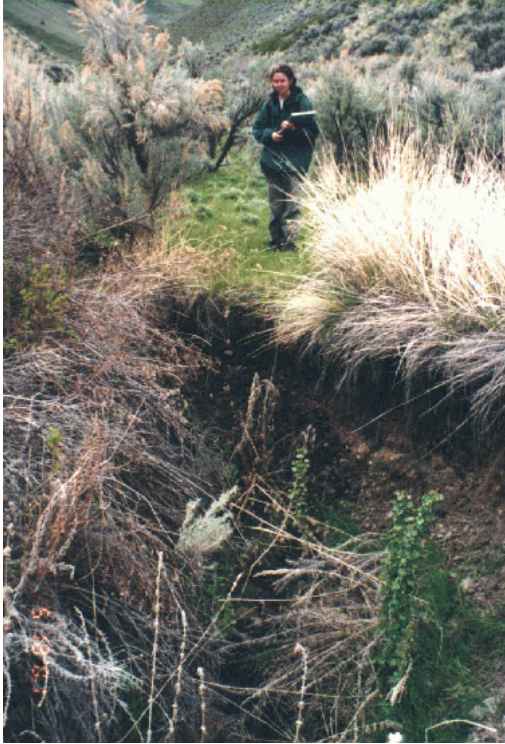
Figure 24. Dipping Vat photo point 3. View of headcut looking upstream. May 18, 2001.

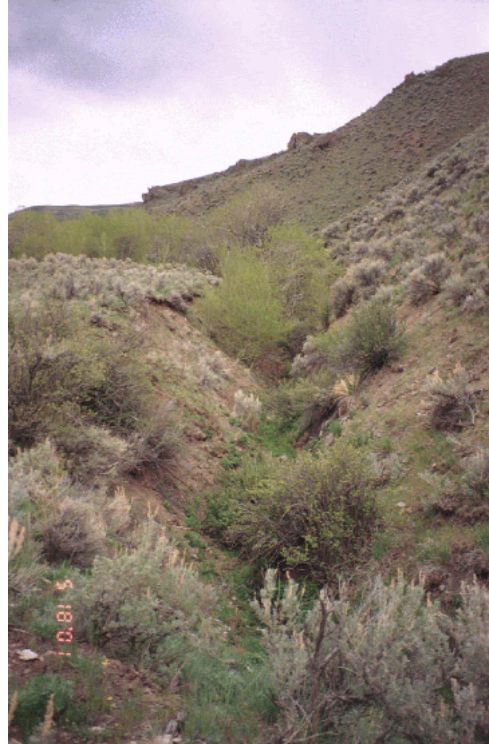
Figure 25. Dipping Vat photo point 12. View of gully with aspen growing in bottom. May 18, 2001.

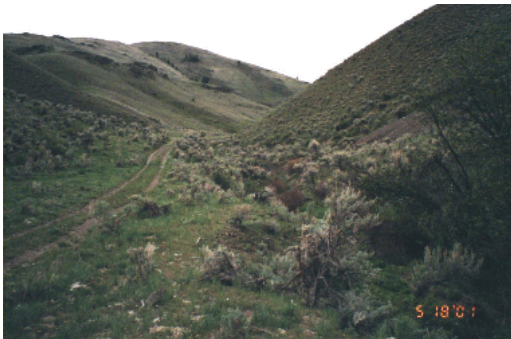
Figure 26. Dipping Vat photo point 10. View upstream showing proximity of road to stream channel. May 18, 2001.

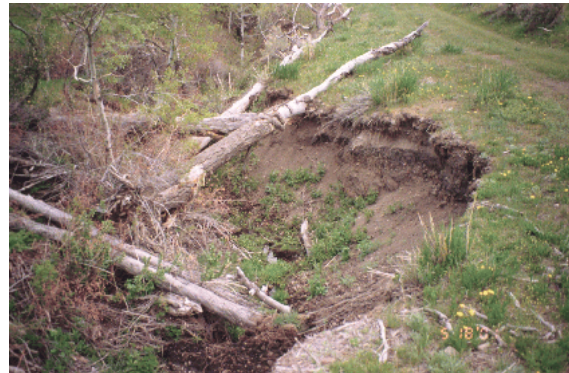
Figure 27. Dipping Vat photo point 13. Example of naturally erosive soils. May 18, 2001.

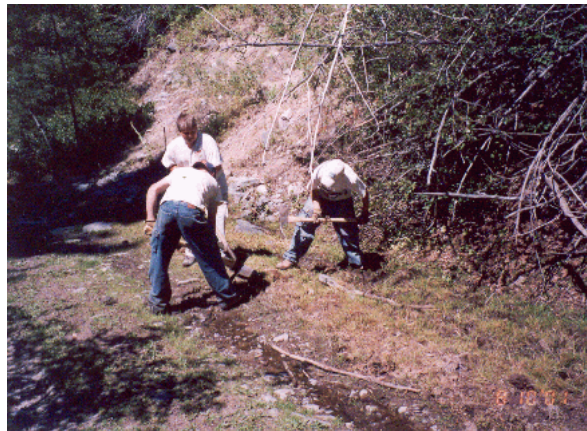
Figure 32. Youth Employment Program participants digging trenches to improve drainage. August 10, 2001.

In 2001, the BLM dug waterbars and drainage ditches on two spur roads off the West Fork Wimpey Road to improve drainage. Approximately three miles of road were maintained. In addition, in a section where the stream was diverted into the road for 1/4 mile by downed trees, the trees were removed and the stream was redirected back into its original channel.
